Sofia Energy Centre
37 entr.2 Galichitsa Street, 1164 Sofia, Bulgaria
arch. Evelina Stoykova

Demonstration Project for Energy Efficiency in Multi-dwelling Houses with Individual Heating Radomir town, Bulgaria

CASE STUDIES REPORT

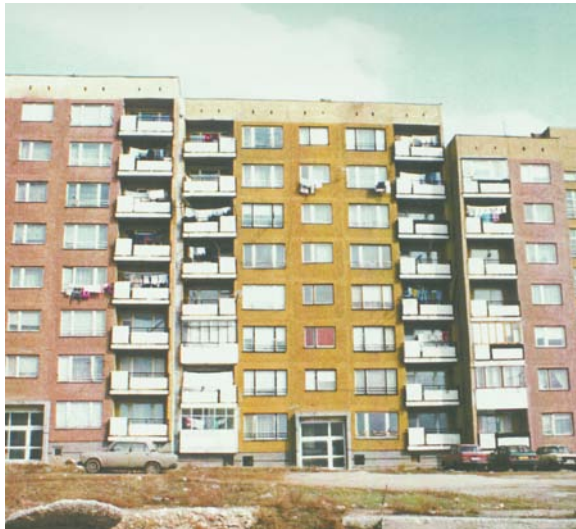
Before the refurbishment

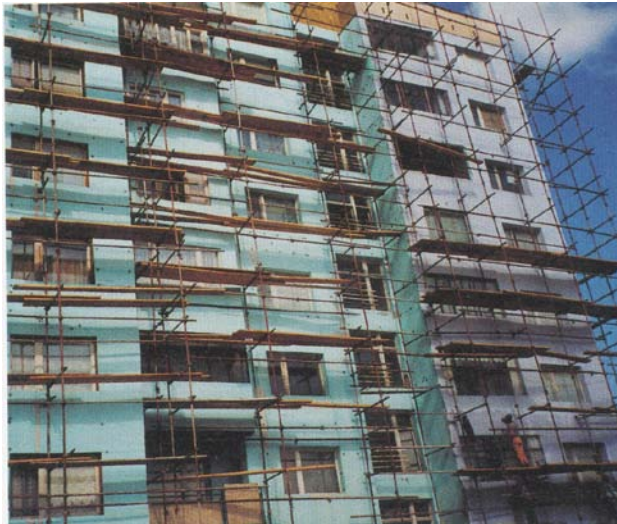
During the refurbishment

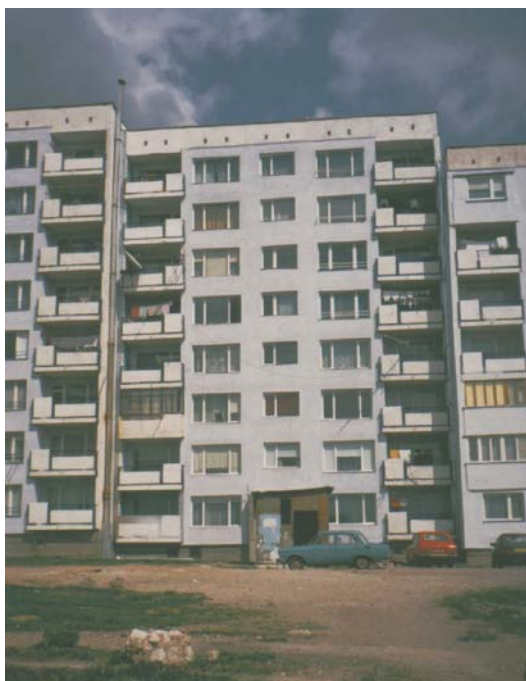
After the refurbishment
