Examples of refurbishment

WP2 overview of refurbishment projects for the InoFin project

February 2007

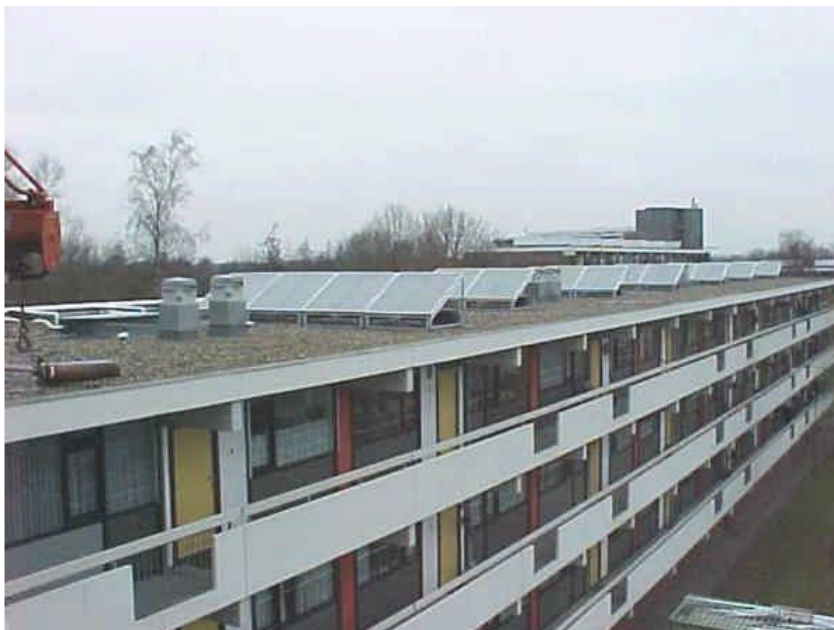
Figure 1.1 *Solar water heating system in apartment building in Veenendaal (NL)*

The project started with the replacement of the old boilers with new, very efficient condensing boilers. The old heating pipe system and radiators were not well suited for these new boilers. To improve energy savings, new piping and radiators, adjusted for the new heat capacity, were installed. The hot tap water supply was also changed. Electric boilers and geysers were replaced with a collective system combined with individual solar water heaters (2.25 m² each) for every apartment. A universal control unit was installed. This unit controls the room temperature (room thermostat) and minimal tap water temperature. It also monitors the heat obtained per apartment for individual payment. To improve living conditions, a balanced mechanical ventilation system was installed in all dwellings. The housing cooperative gave tenants the opportunity to suggest other improvements in their apartment, such as a new kitchen unit, so these could be combined with the other construction works.

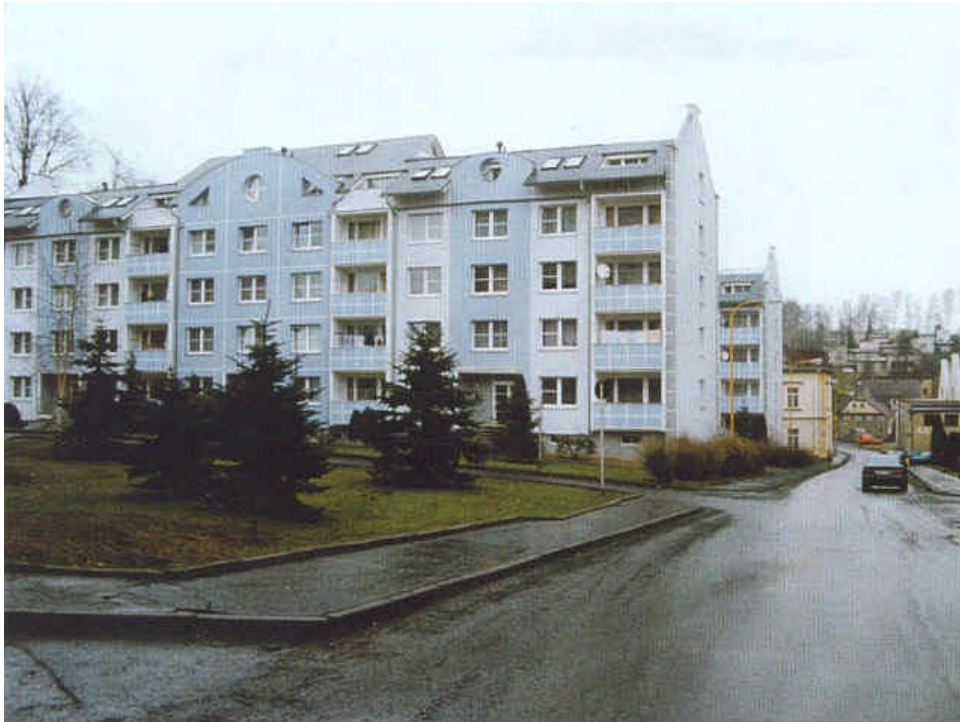
Figure 1.2 *Refurbished panel building in Rumburk (CZ)*

In the year 1997 the Czech Energy Agency provided a grant to demonstrate possible improvement of energy characteristics of the house. In addition, a double-sloping roof with an additional floor of new flats replaced the flat roof.

- Outside walls - Thermal insulation of frontal and gable walls were insulated using 70 mm thick polystyrene boards.
- Doors and windows - Old windows were replaced by new plastic ones with $U = 2,1 \text{ W} \cdot \text{m}^{-2} \cdot \text{K}^{-1}$, with silicon EUROSTRIP sealing, doors having brush insulation.
- Roof - Old flat roof was replaced by double-sloping roof with an additional floor of new flats built in. The thermal insulation was done using 150 mm thick polystyrene boards.
- Inner space - the floor above not heated with underground space was insulated using 50 mm thick polystyrene boards.

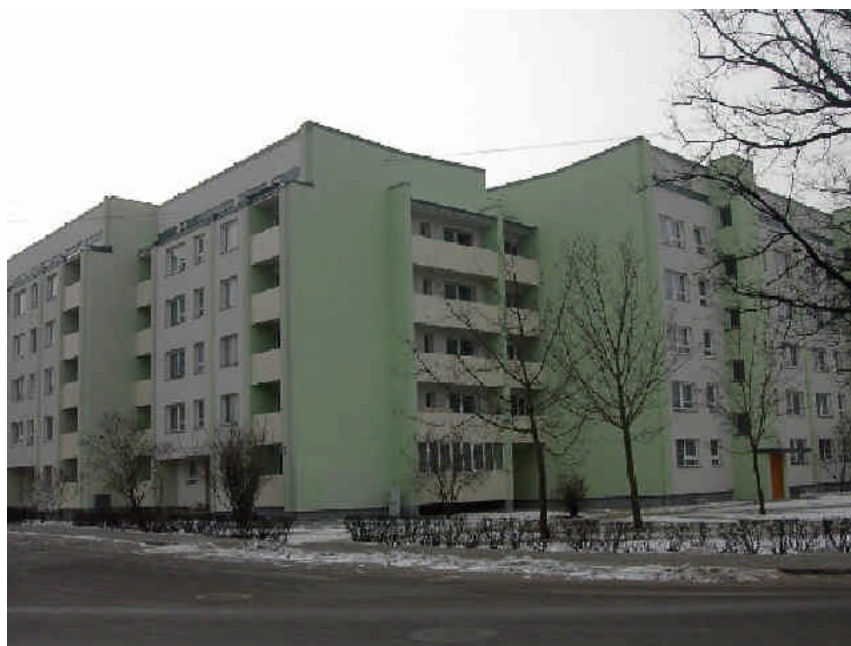
Figure 1.3 *Refurbished panel buildings in Valmiera (LV)*

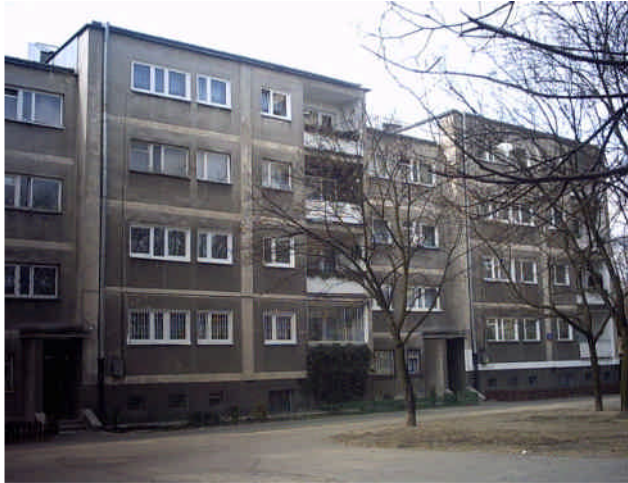
Figure 1.4 *The building in Bukietowa street (Warsaw, PL) before refurbishment, April 2003*

This project concerns the process of energy efficiency refurbishment of a building owned by a housing cooperative, located at Bukietowa Street 8 in Warsaw. The building described was constructed in 1963 with typical panel technology. It has 48 dwellings, 2400 m² usable area and is occupied by 98 persons (most pensioners and low income families). For the refurbishment, use has been made of funds from the Polish Thermo-modernisation Fund.

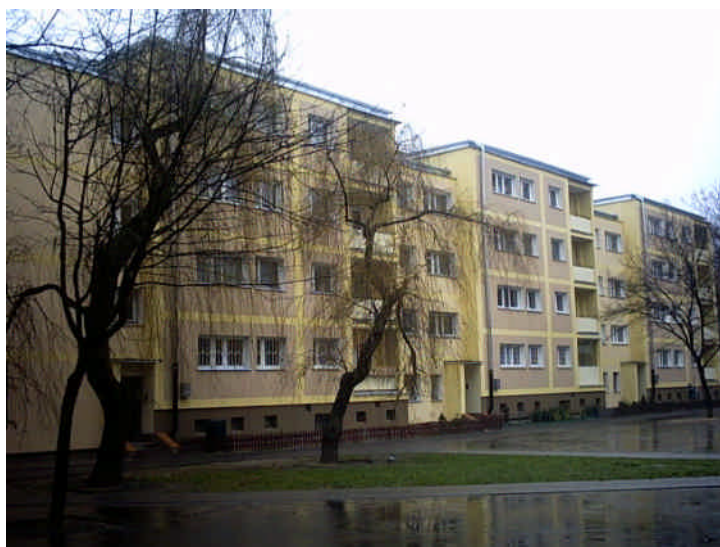
Figure 1.5 *The building in Bukietowa street (Warsaw, PL) after refurbishment, Oct. 2003*

- Replacement of central heating installation by new fully automated one (pipes, radiators, thermostatic valves).
- Insulation of external walls with 13 cm of styrofoam.
- Insulation of windows above staircases with polycarbonate panel.
- Insulation of roof with 12 cm of mineral wool.

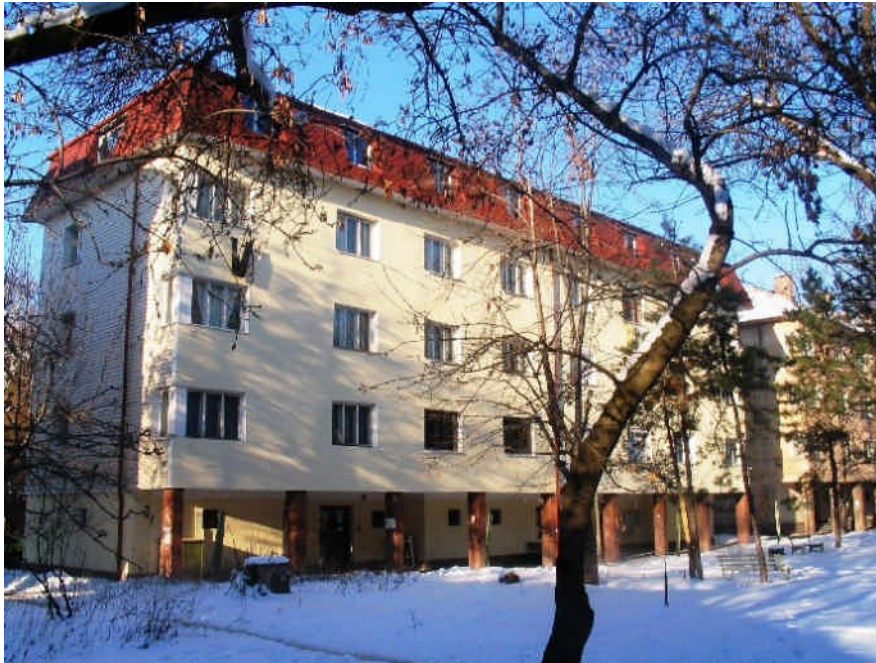
Figure 1.6 *The building Zaharna Fabrica (BG) after refurbishment*

Energy consumption before renovation [kWh/m ² per year]		Energy consumption after renovation [kWh/m ² per year]	
Heating	162.6	Heating	60.2
Hot water	30.5	Hot water	43.8
Integrated energy performance	194.1	Integrated energy performance	105.6
<i>Percentage of energy saved 46%</i>
